# Thursford Barn, Norfolk

**Architect**  
Lynch Architects  
**Location**  
Near Holkham, Norfolk  
**Completed** 2013

**By Hugh Strange**

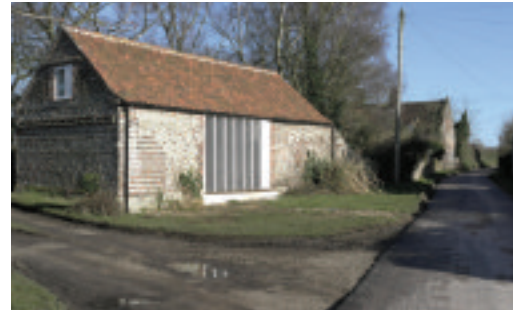
Shuttered full-height windows are set into the brick and flint wall.

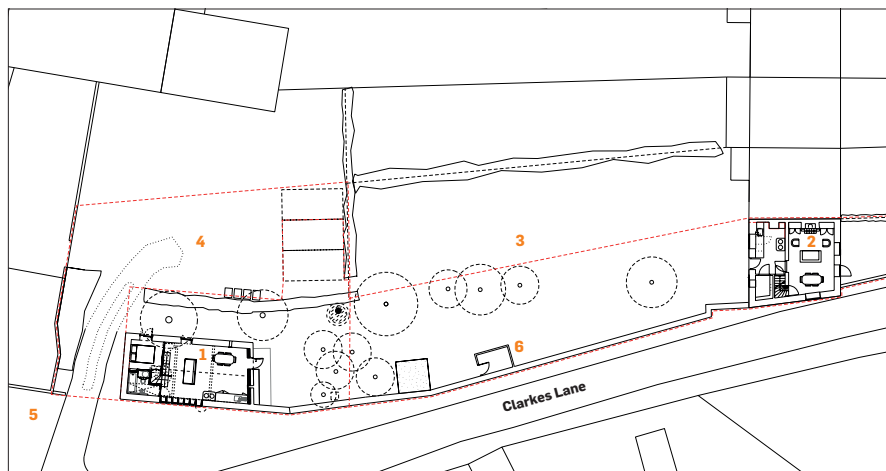
#### Site plan

- 1 Barn
- 2 Cottage
- 3 Shared garden
- 4 Car park & access
- 5 Village green
- 6 Privy

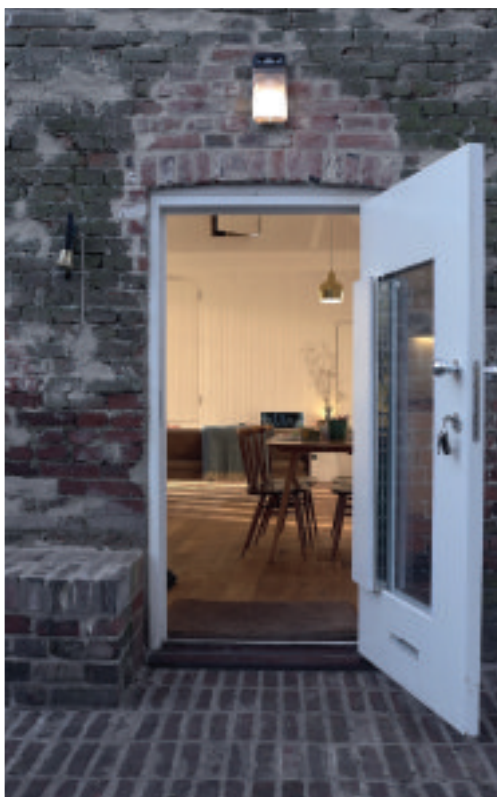
A new threshold with a brick bench defines the garden entrance.

New windows and doors are made from painted joinery except for two frameless arrow slit windows fixed directly to the inside of the masonry. A new brick threshold and bench redefine the external space adjacent to the garden
